**Survey Report on
Sandal Entrapment Accidents
in Escalators
(Product Safety Test)**

May, 2008

1. Background and objectives of the Survey

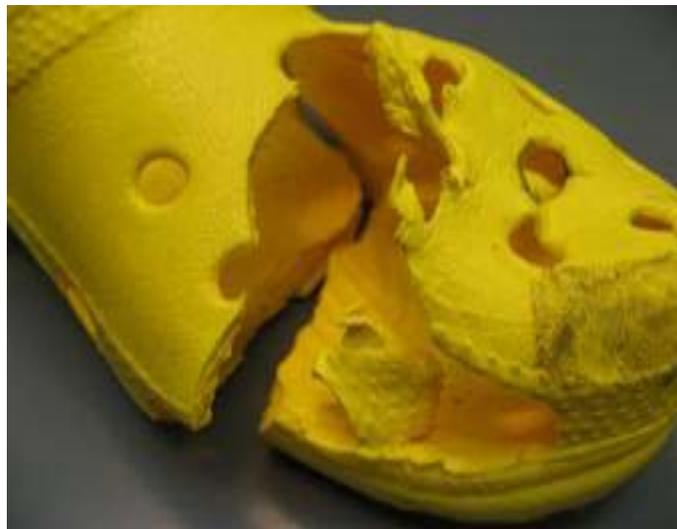
Figure 1: A child injured her toe in an accident.

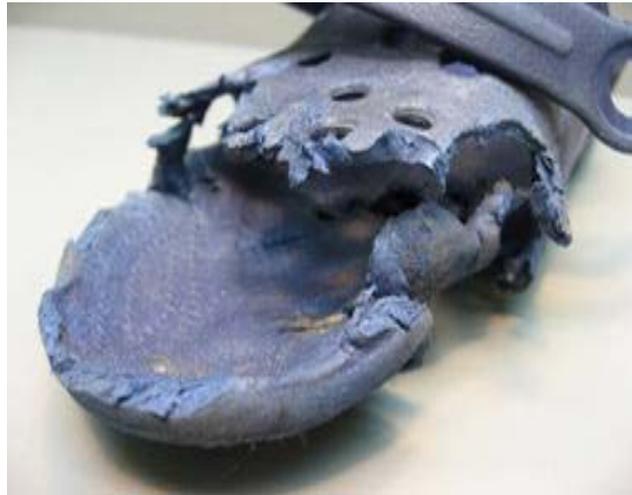
Figure 2: A child injured her toe in an accident.

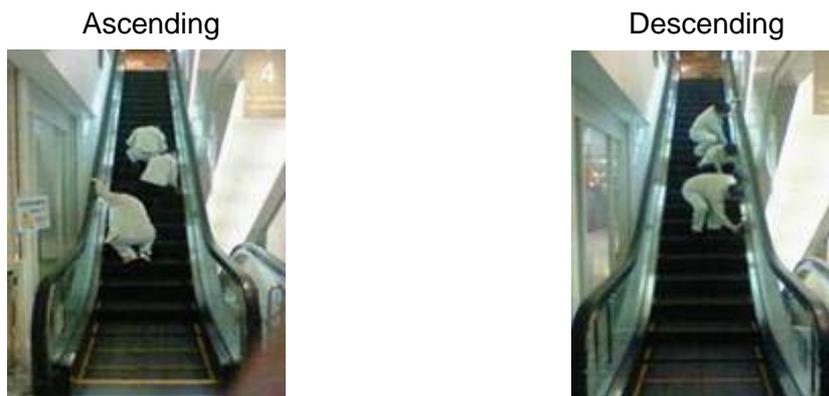
Picture 4: Reproduction test

Apply load of about 1 Kgf/cm² by hand horizontally and at an angle of 45 degrees to the samples placed on a step.

Under the above conditions, 60 reproduction tests per sample were performed on each escalator, coming to a grand total of 240 tests in four escalators. Reproduction tests are shown in Table 8.

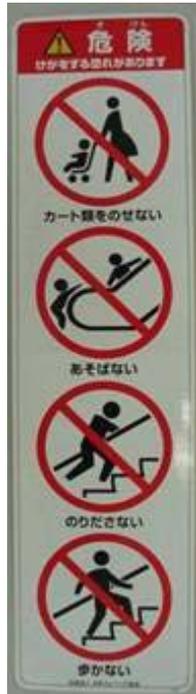
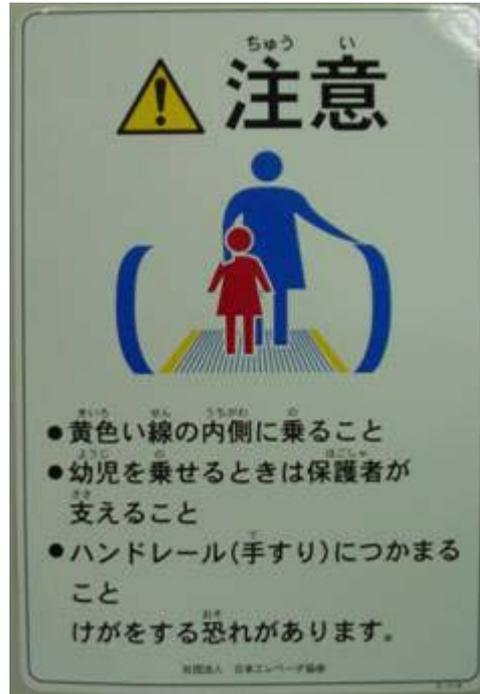
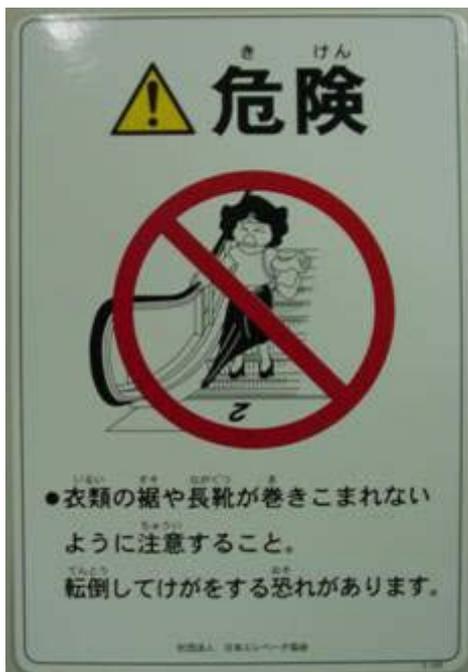
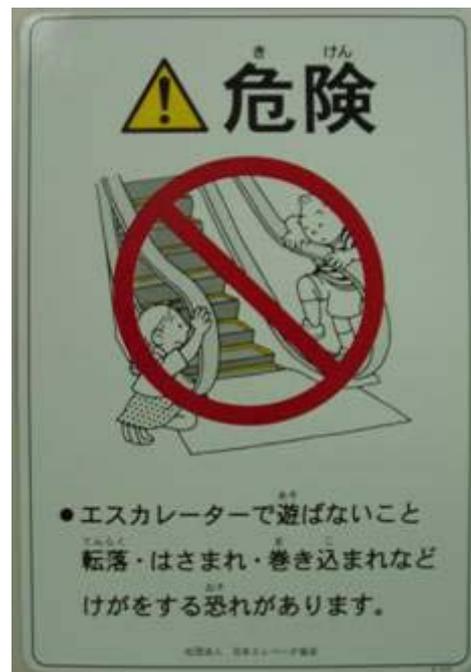
11.1 Caution stickers for the escalator (before accidents)

Examples of caution stickers for the escalator which were prepared by the Japan Elevator Association (JEA), manufacturers and maintenance companies are as follows.

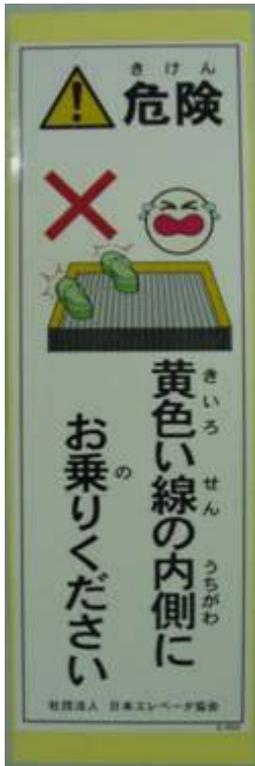
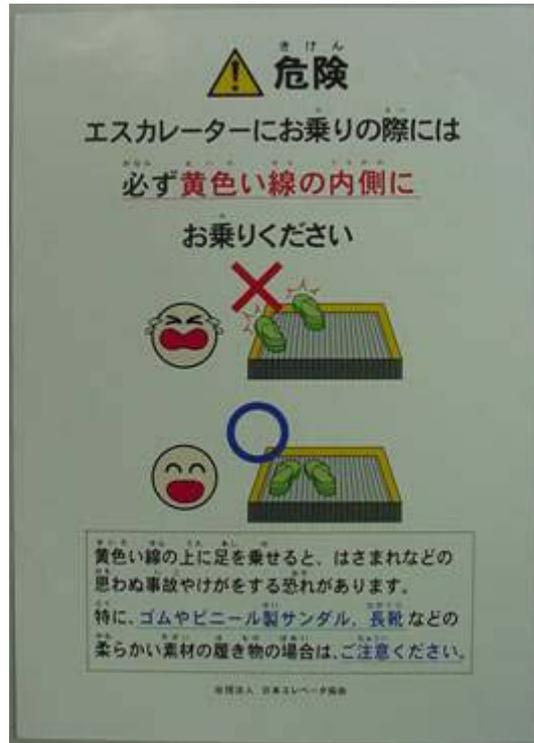
11.2 Caution sticker for the escalator (after accidents)

In response to the accidents, The Japan Elevator Association (JEA), manufacturers and maintenance companies have made new caution stickers and leaflets to prevent the similar accidents. The examples are indicated below.
